Ad-Hoc Fire Resistance Test Utilising The General Principles Of BS EN 1363-1: 2012 On Five Specimens Of Linear Gap Seals And Four Specimens Of Penetration Seals Mounted Within A Plasterboard Wall Construction

326796/B

Everbuild Building Products

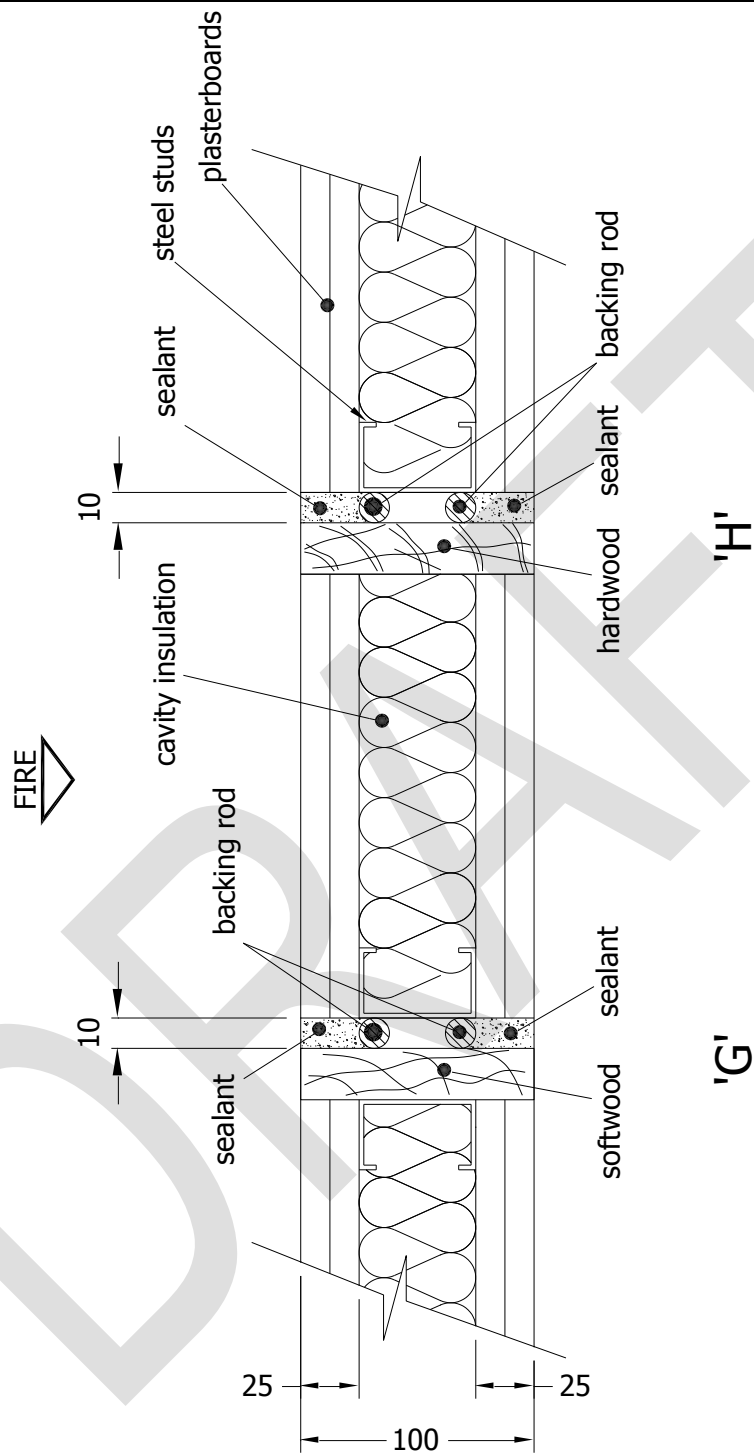
Figure 3 – Section through Wall Specimens 'G' and 'H'

SECTION THROUGH WALL SPECIMENS 'G' AND 'H'

<u>Item</u>	<u>Description</u>
Details of Wall Cavity Barriers	
1. Specimen 'G'	
Details of sealant	
i. manufacturer	: Everbuild
ii. reference	: Everbuild Firemate intumescent sealant/Fireseal 300/AC95
iii. material	: Acrylic sealant
iv. overall size of sealant	: Double seal, each 10 mm wide x 25 mm thick x 1500 mm long

v. application method	: Cartridge gunned at both faces of cavity
vi. overall size of cavity	: 10 mm wide x 100 mm deep x 1000 mm long
Details of backing rod

i. material	: Polyethylene
ii. size	: 13 mm diameter
iii. fixing method	: Friction fit within cavity
Cavity facings	: Plasterboards to general commercial softwood
Details of timber

i. size	: 34 mm wide x 100 mm deep
ii. fixing method	: Screw fixed to steel stud of partition
Cavity insulation within gap	: None
2. Specimen 'H'	
Details of sealant

i. manufacturer	: Everbuild
ii. reference	: Everbuild Firemate intumescent sealant/Fireseal 300/AC95
iii. material	: Acrylic sealant
iv. overall size of sealant	: Double seal, each 10 mm wide x 25 mm thick x 1500 mm long

i. material	: Polyethylene
ii. size	: 13 mm diameter
iii. fixing method	: Friction fit within cavity
Cavity facings	: Plasterboards to general commercial hardwood
Details of timber

i. size	: 34 mm wide x 100 mm deep
ii. fixing method	: Screw fixed to steel stud of partition
Cavity insulation within gap	: None

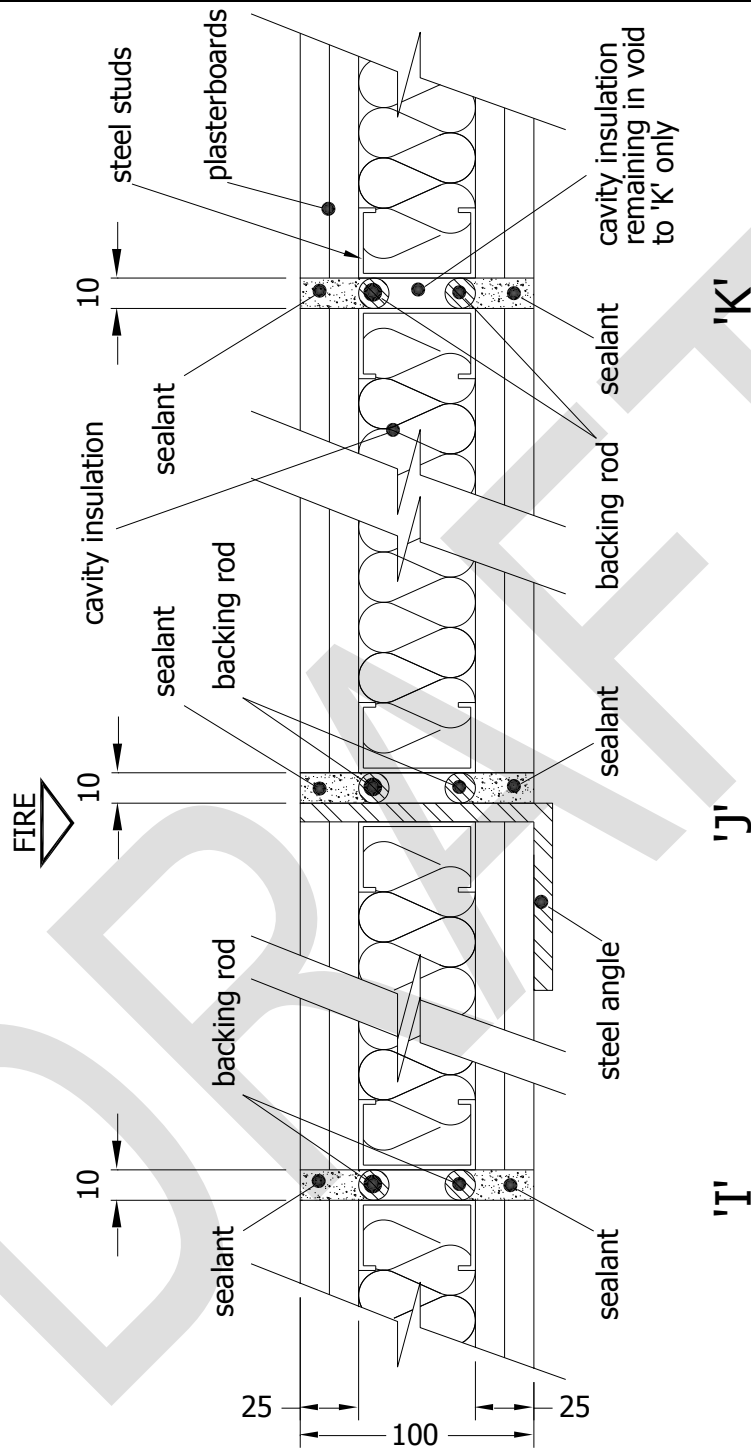
Figure 4 – Section through Wall Specimens 'I, J' and 'K'

SECTION THROUGH WALL SPECIMENS 'I, J' AND 'K'

<u>Item</u>	<u>Description</u>
3. Specimen 'I'	
Details of sealant	
i. manufacturer	: Everbuild
ii. reference	: Everbuild Firemate intumescent sealant/Fireseal 300/AC95
iii. material	: Acrylic sealant
iv. overall size of sealant	: Double seal, each 10 mm wide x 25 mm thick x 1500 mm long

v. application method	: Cartridge gunned at both faces of cavity
vi. overall size of cavity	: 10 mm wide x 100 mm deep x 1000 mm long
Details of backing rod

i. material	: Polyethylene
ii. size	: 13 mm diameter
iii. fixing method	: Friction fit within cavity
Cavity facings	: Plasterboards to plasterboards
Cavity insulation within gap	: None

4. Specimen 'J'	
Details of sealant	
i. manufacturer	: Everbuild
ii. reference	: Everbuild Firemate intumescent sealant/Fireseal 300/AC95
iii. material	: Acrylic sealant
iv. overall size of sealant	: Double seal, each 10 mm wide x 25 mm thick x 1500 mm long

i. material	: Polyethylene
ii. size	: 13 mm diameter
iii. fixing method	: Friction fit within cavity
Cavity facings	: Plasterboards to steel
Details of steel

i. size	: Angle section 8 mm thick x 80 mm x 150 mm
ii. fixing method	: Screw fixed to steel stud of partition
Cavity insulation within gap	: None
5. Specimen 'K'	
Details of sealant

i. manufacturer	: Everbuild
ii. reference	: Everbuild Firemate intumescent sealant/Fireseal 300/AC95
iii. material	: Acrylic sealant
iv. overall size of sealant	: Double seal, each 10 mm wide x 25 mm thick x 1500 mm long

i. material	: Polyethylene
ii. size	: 13 mm diameter
iii. fixing method	: Friction fit within cavity
Cavity facings	: Plasterboards to plasterboards
Cavity insulation within gap	: The cavity insulation from the partition continues into the gap between the plasterboard faces

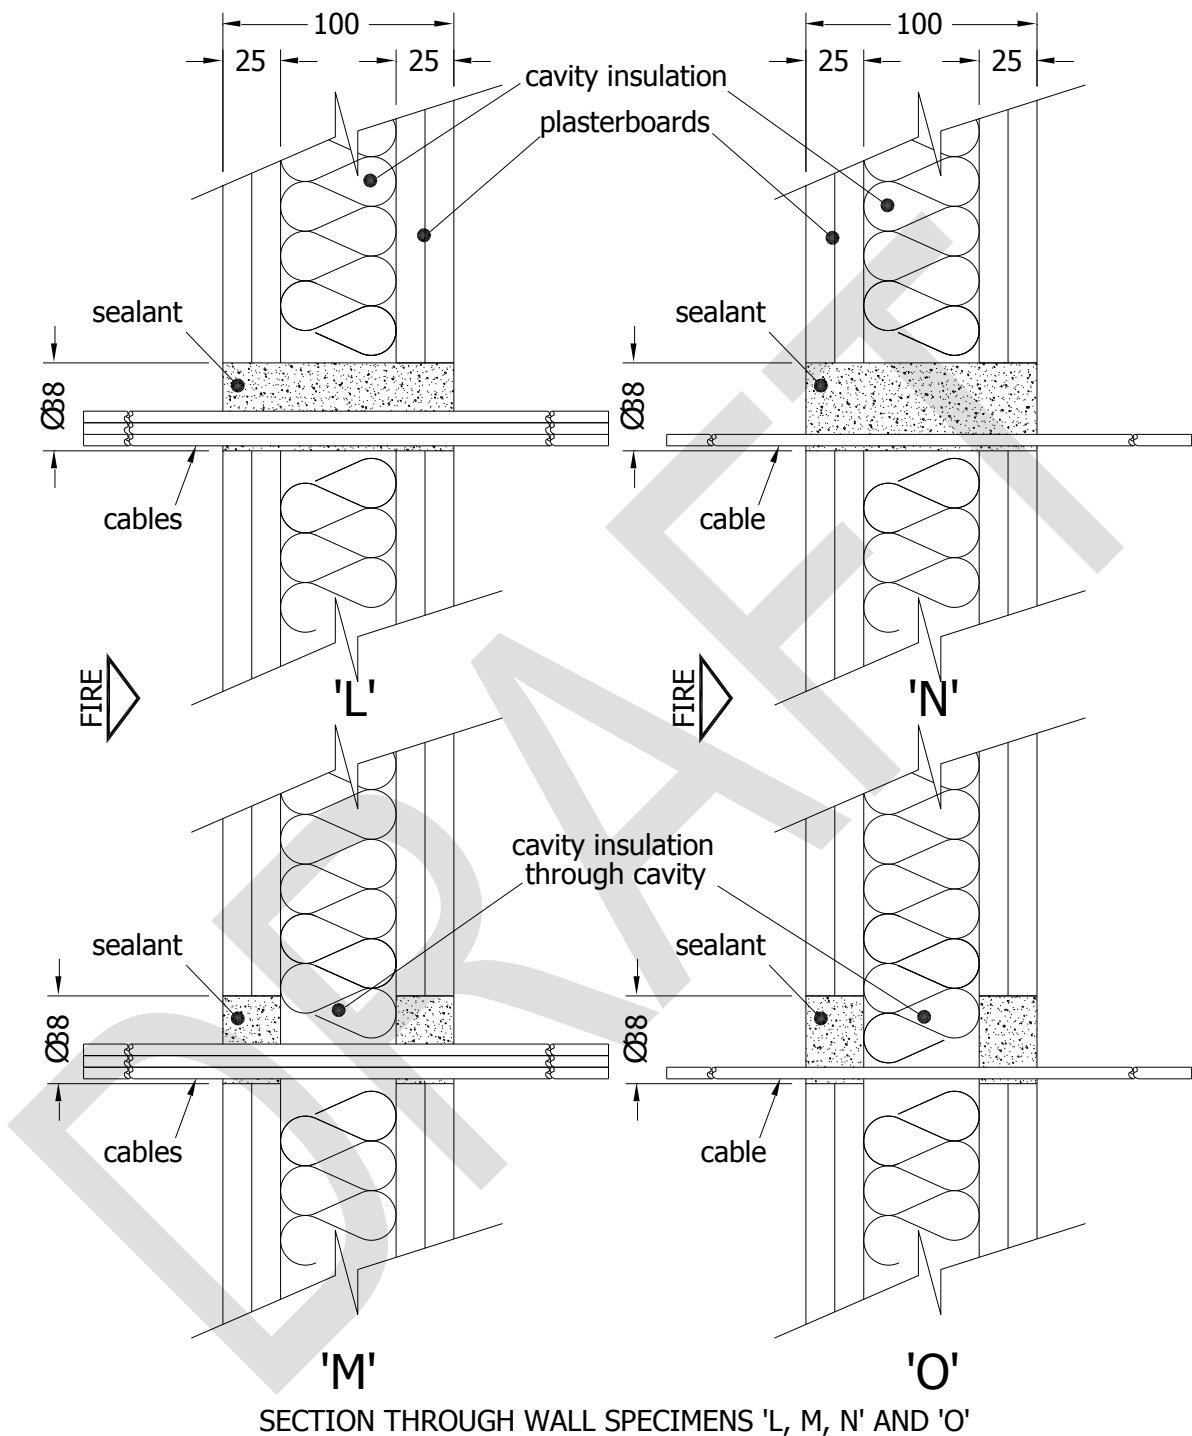
Figure 5 – Section through Wall Specimens 'L, M, N' and 'O'

SECTION THROUGH WALL SPECIMENS 'L, M, N' AND 'O'

<u>Item</u>	<u>Description</u>
6. Specimen 'L'	
Details of sealant	
i. manufacturer	: Everbuild
ii. reference	: Everbuild Firemate intumescent sealant/Fireseal 300/AC95
iii. material	: Acrylic sealant
iv. overall size of sealant	: Double seal, each 38 mm diameter x 100 mm thick

v. application method	: Cartridge gunned to infill cavity
vi. overall size of cavity	: 38 mm diameter x 100 mm wide
Penetration	: Five communication cables, each 5 mm overall diameter, 4 core copper, laid at the bottom of the hole
Cavity facings	: Plasterboards to plasterboards
Cavity insulation within gap	: None, entire cavity filled with sealant

7. Specimen 'M'	
Details of sealant	
i. manufacturer	: Everbuild
ii. reference	: Everbuild Firemate intumescent sealant/Fireseal 300/AC95
iii. material	: Acrylic sealant
iv. overall size of sealant	: Double seal, each 38 mm diameter x 25 mm thick

v. application method	: Cartridge gunned at both faces of cavity
vi. overall size of cavity	: 38 mm diameter x 100 mm wide
Penetration	: Five communication cables, each 5 mm overall diameter, 4 core copper, laid at the bottom of the hole
Cavity facings	: Plasterboards to plasterboards
Cavity insulation within gap	: The cavity insulation from the partition continues into the gap between the plasterboard faces

8. Specimen 'N'	
Details of sealant	
i. manufacturer	: Everbuild
ii. reference	: Everbuild Firemate intumescent sealant/Fireseal 300/AC95
iii. material	: Acrylic sealant
iv. overall size of sealant	: 38 mm diameter x 100 mm thick

v. application method	: Cartridge gunned to infill cavity
vi. overall size of cavity	: 38 mm diameter x 100 mm wide
Penetration	: Single communication cable, 5 mm overall diameter, 4 core copper, laid at the bottom of the hole
Cavity facings	: Plasterboards to plasterboards
Cavity insulation within gap	: None, entire cavity filled with sealant

9. Specimen 'O'	
Details of sealant	
i. manufacturer	: Everbuild
ii. reference	: Everbuild Firemate intumescent sealant/Fireseal 300/AC95
iii. material	: Acrylic sealant
iv. overall size of sealant	: Double seal, each 38 mm diameter x 25 mm thick

v. application method	: Cartridge gunned at both faces of cavity
vi. overall size of cavity	: 38 mm diameter x 100 mm wide

Penetration	:	Single communication cable, 5 mm overall diameter, 4 core copper, laid at the bottom of the hole
Cavity facings	:	Plasterboards to plasterboards
Cavity insulation within gap	:	The cavity insulation from the partition continues into the gap between the plasterboard faces

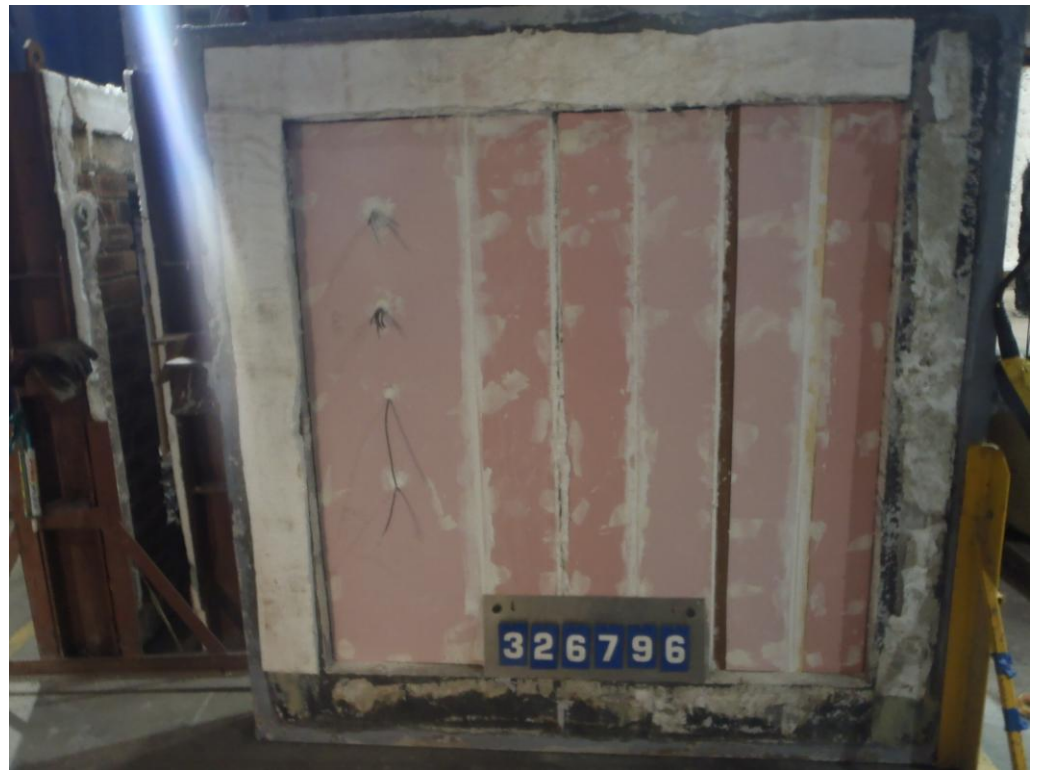
The exposed face of the wall construction prior to testing

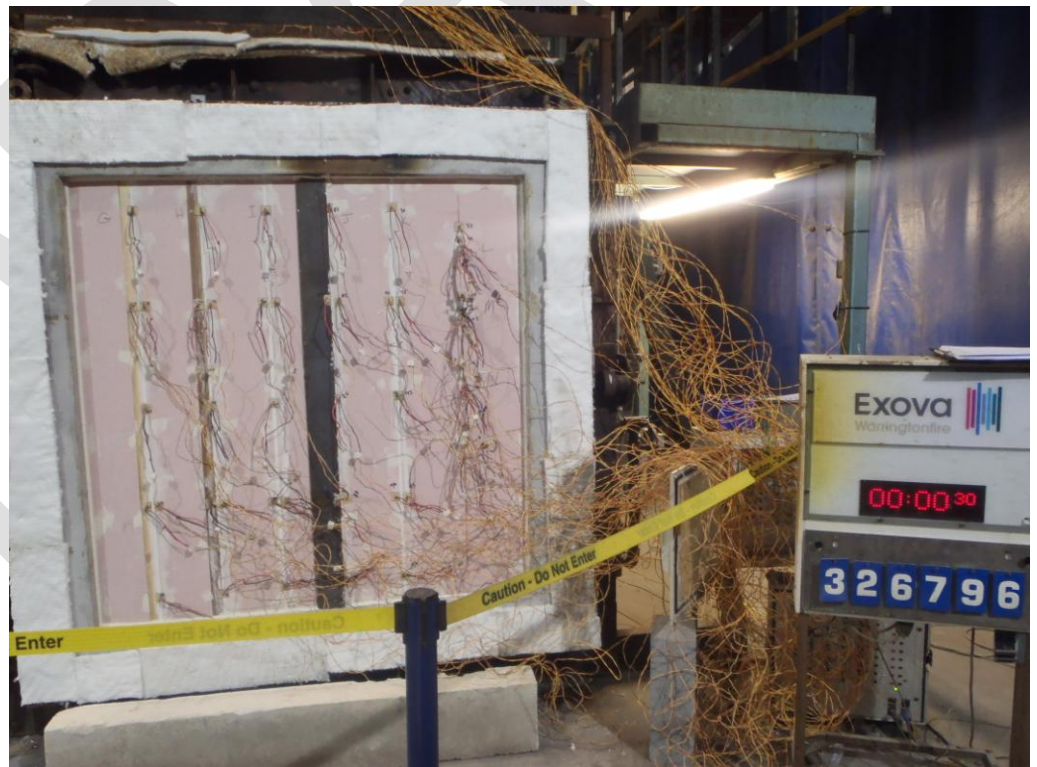
The unexposed face of the wall construction prior to testing

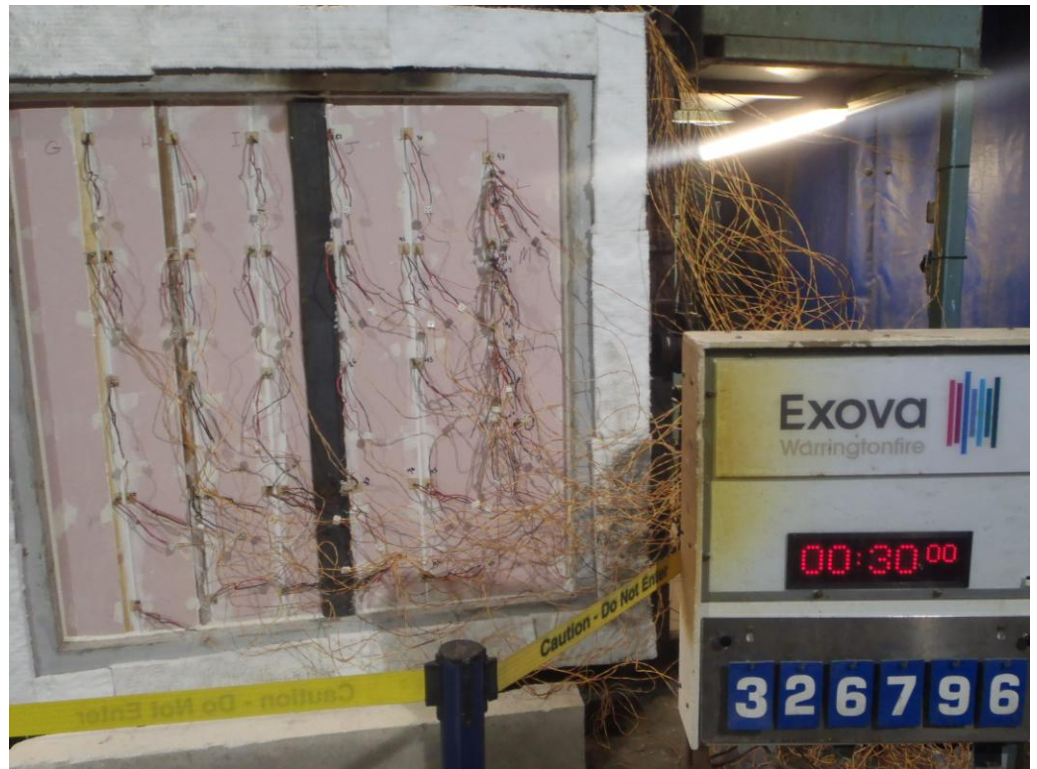
The unexposed face of the wall construction after 30 minutes of testing

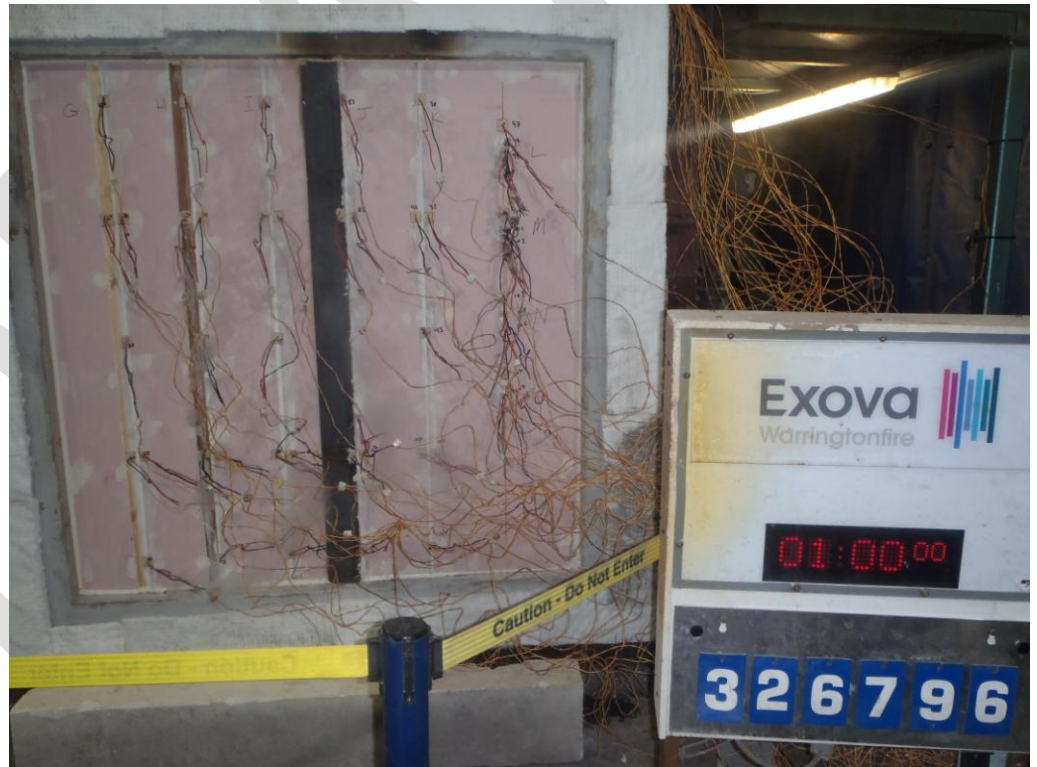
The unexposed face of the wall construction after 60 minutes of testing

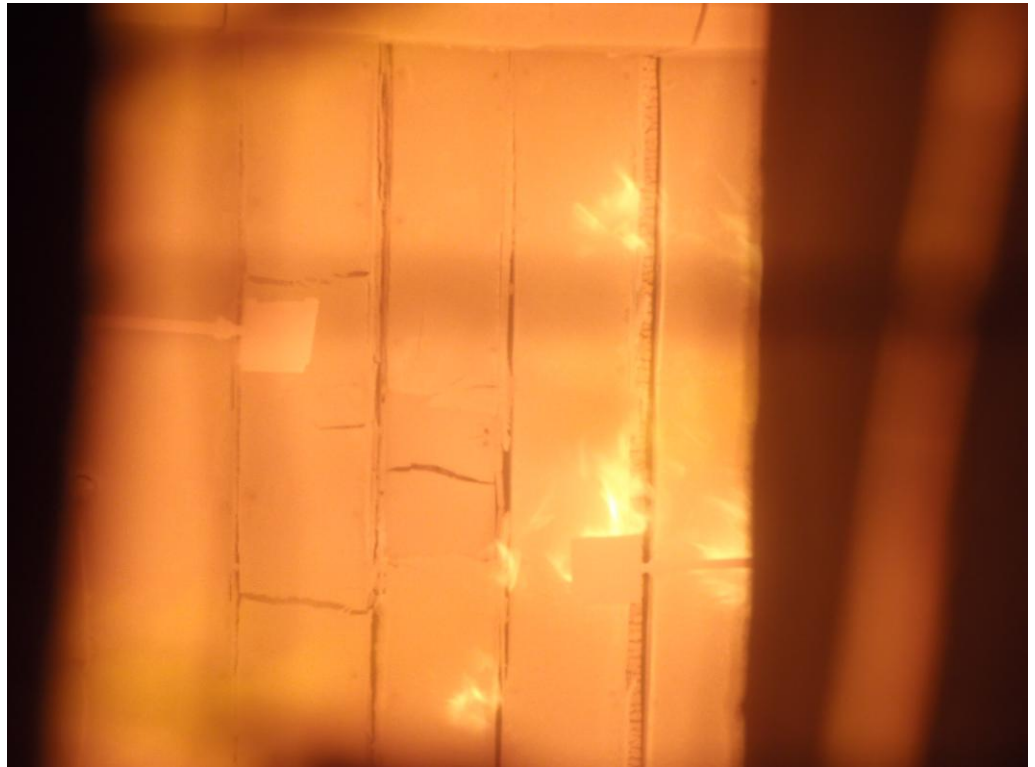
The exposed face of the wall construction after 90 minutes of testing

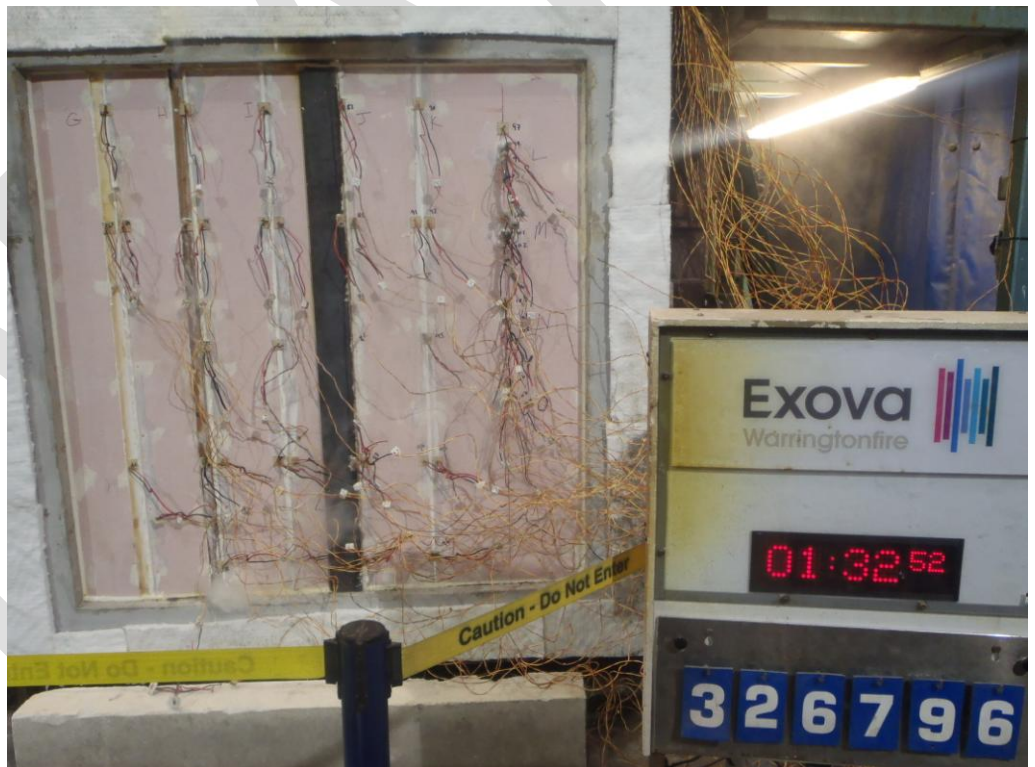
The unexposed face of the wall construction after 92 minutes of testing

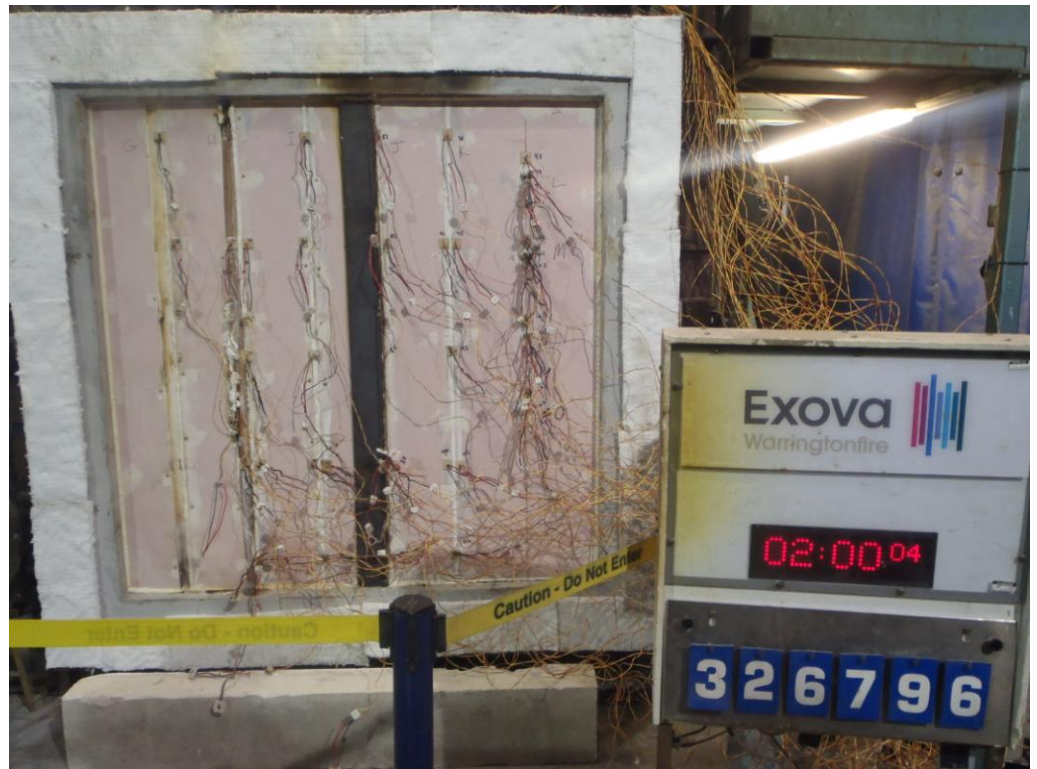
The unexposed
face of the wall
construction after
120 minutes of
testing

106	50	The timber substrate begins to degrade at the head and mid height of Specimen H.
120	00	No significant visible change. All specimens continue to satisfy integrity criteria. All specimens (excluding Specimens J, L and M) continue to satisfy the insulation criteria.
122	00	The timber substrate of Specimens G & H continues to degrade. The wall mounted specimens are blanked off at the sponsors request to allow the test to continue.
300	00	The test is discontinued at the request of the sponsor.

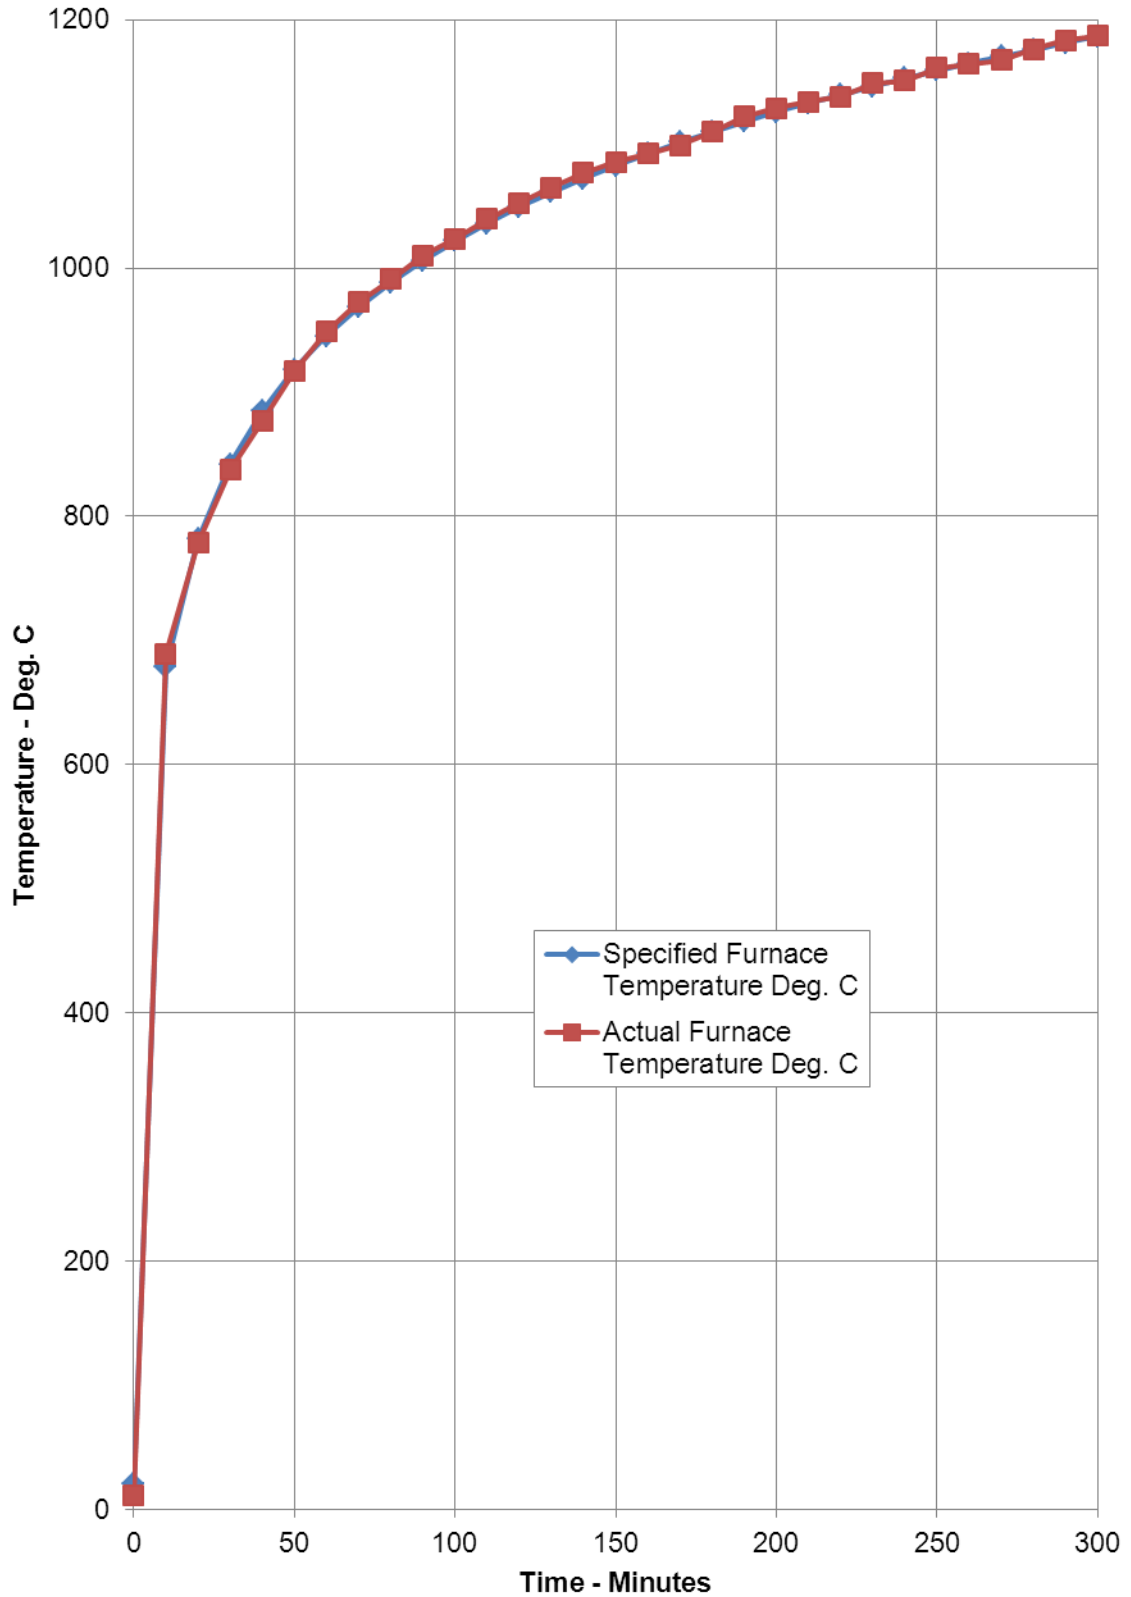
Graph Showing Mean Furnace Temperature, Together With The Temperature/Time Relationship Specified In BS EN 1363-1: 2012

Mean Furnace Temperature, Together With The Temperature/Time Relationship Specified In BS
EN 1363-1: 2012

Time Mins	Specified Furnace Temperature Deg. C	Actual Furnace Temperature Deg. C
0	20	12
10	678	689
20	781	778
30	842	837
40	885	877
50	918	917
60	945	949
70	968	972
80	988	991
90	1006	1010
100	1022	1023
110	1036	1039
120	1049	1053
130	1061	1065
140	1072	1077
150	1082	1085
160	1092	1092
170	1101	1099
180	1110	1110
190	1118	1122
200	1126	1129
210	1133	1134
220	1140	1138
230	1146	1149
240	1153	1151
250	1159	1161
260	1165	1164
270	1170	1167
280	1176	1176
290	1181	1183
300	1186	1187
